TEST REPORT

ESD EVALUATION OF THE 7800, 2100 & CX-24

Subject: "ESD" Evaluation of the 7800 , 2100 & CX-24
Proline Controller

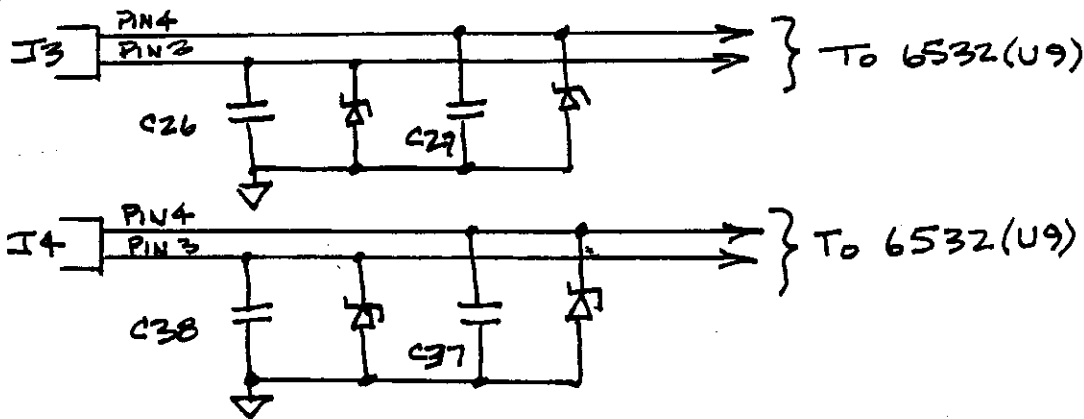
FIGURE 1

The 7800 console, 6532 IC, fails at an "ESD" level of 25KV applied to port 1 or port 2 with the controllers inserted. An acceptable solution is to add 12 Volt zener diodes, C062081, to Rev. 7.0 P.C.B. as shown in figure 1.

Provide the basic "ESD" protection for the console ports, by adding the zeners as identified in figure 1. (Dan Schwinn of GCC was notified 3/15/84 by FAX, ref. C024673-159, that the additional zeners are required for "ESD" protection.)
