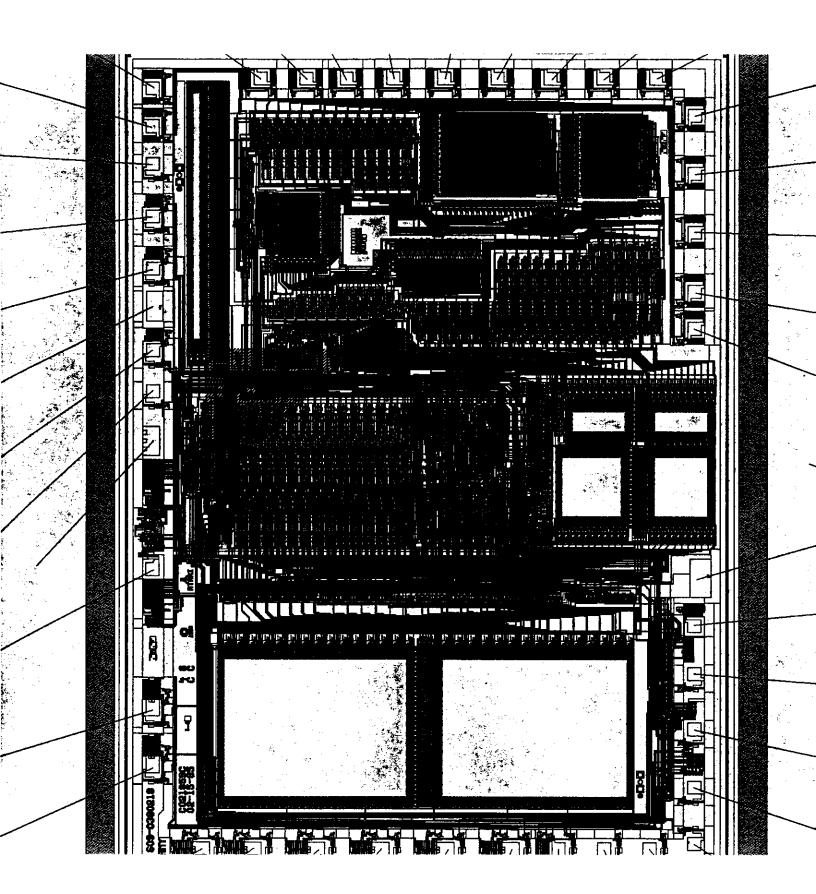
ORIGINAL &

Problems If A is unknown then SILOS models both transistors as DN and result is unknown.
